Re: Hazardous Waste Compliance Inspection
EPA ID Number KSD007246846

RCRA COMPLIANCE INSPECTION REPORT GENERATORS AND TRANSPORTERS CHECKLIST

T/S/D Facilities Checklist

Figure 1.1
HRI WASTESTREAM CHANNELING

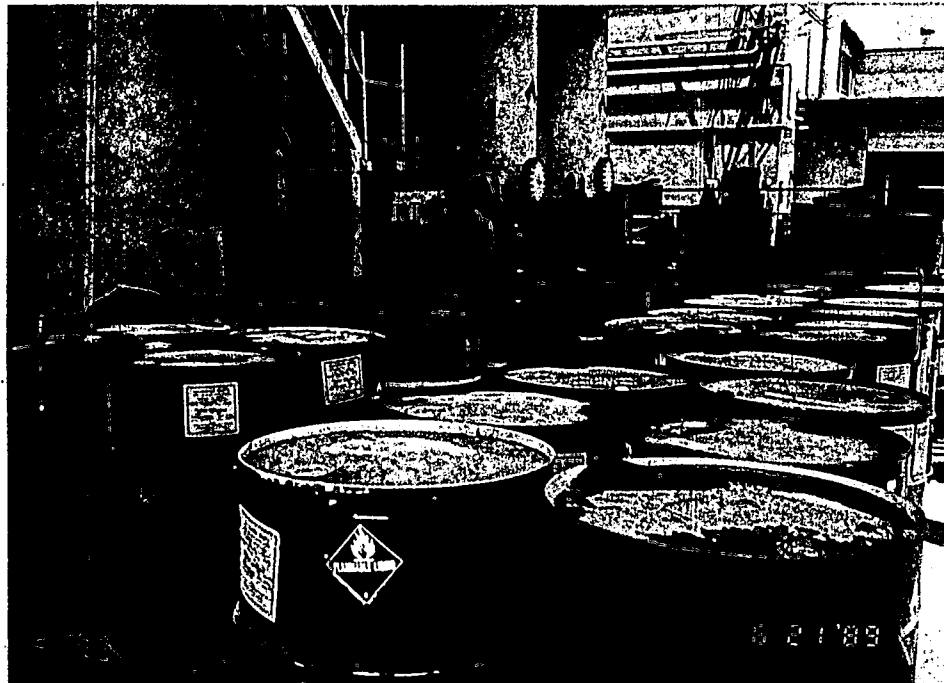
Photo No. 3 Time: _____ Hrs.

- There are 8 hazardous waste tanks located in the process area (see photo). Five of these are pressure tanks. Following is an inventory of the tanks:
 - Tank 1 is for storage of flammable water. This will eventually be deep wellled at Chem Resources in Tulsa (but first taken to HRI, Tulsa).
 - Tank 2 is for toluene, xylene wastestream for recycle at HRI Tulsa. This is an atmospheric tank.
 - Tank 3 is a blending solvent tank. Waste paint solvent from customers which is used to thin sludges during the blending process.
 - Tank 4 is a waste lacquer thinner (contains acetone) for recycle at HRI Tulsa.
 - Tanks 5 and 6 are both 21,000 gallon kiln fuel tanks. Hold blended waste to be sent to Lafarge/Systech. These are atmospheric tanks.
 - Tank 7 holds straight waste MEK.
 - Tank 8 holds waste liquids for incineration.

The tank process area is considered to have adequate secondary containment.

Comments: Inside tank processing area.

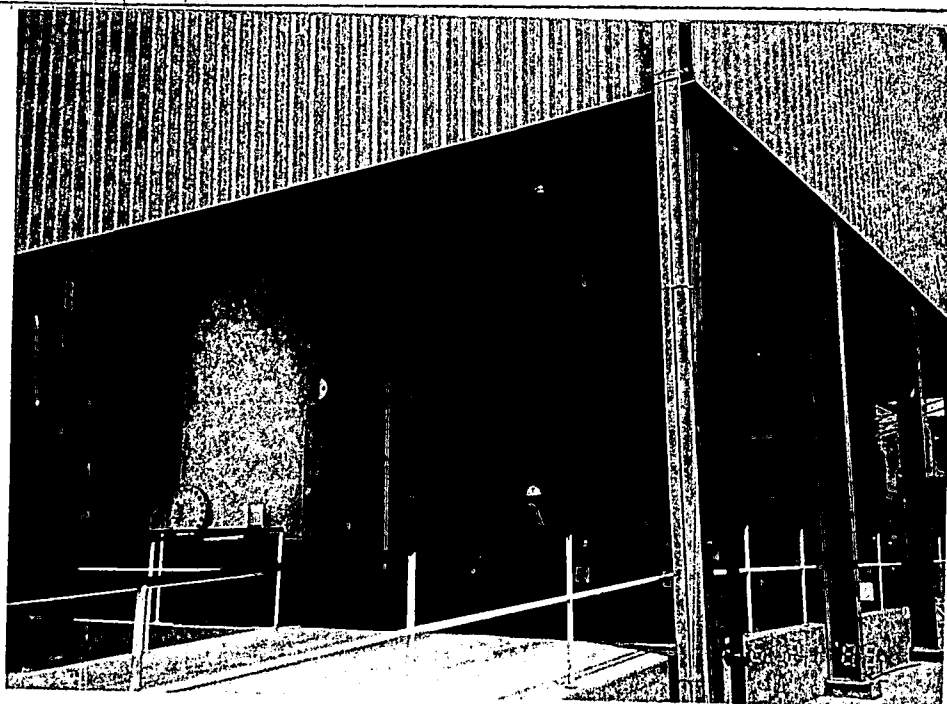
Photo No. 4 Time: _____ Hrs.

Total of 65 drums in process.

Comments: Another view of tank processing area.

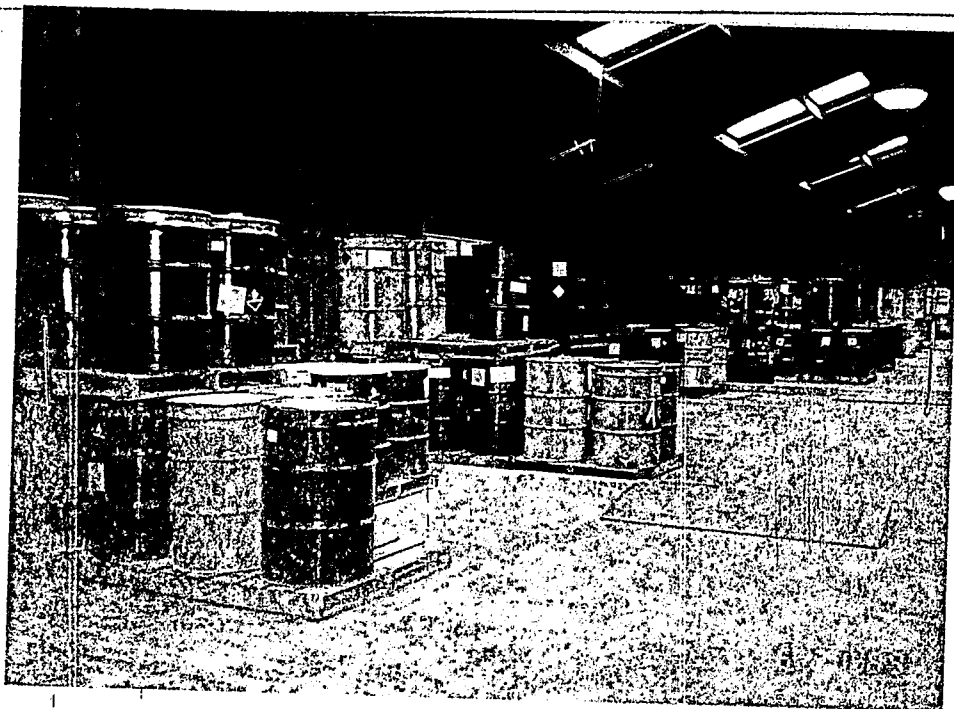
Photo No. 7 Time: _____ Hrs.

* —Total count of hazardous waste drums about 980. Total count of non-hazardous waste drums about 230 (these are mostly ink).

* —At least 2 bulged drums.

* —At least two severely dented drums and several minor dents.

* —At least 2 severely rusted drums.

Warehouse 'C'

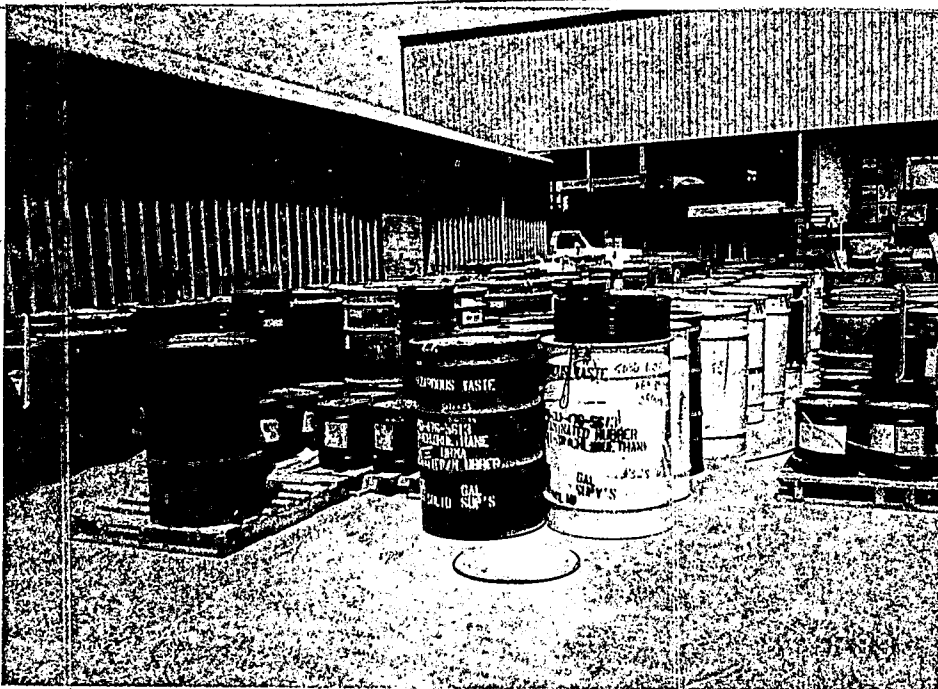
Photo No. 9 Time: _____ Hrs.
Date: 6-21-89 Day: _____
By: Dale T. Stuckey
General Direction Faced: East
Weather Conditions: _____
Type of Camera: Minolta Freedom III
Comments: _____

3. According to 40 CFR 265.177(c) a storage container holding hazardous waste that is incompatible with any other waste or other material stored nearby in other containers, must be separated from the other waste or materials or protected from them by means of a dike, berm, wall, or other device. You had a waste drum with pH 1 stored next to a drum with pH 12 at your truck unloading area.

—4 van loads of drums in storage, total approx 300 to 350 drums. See photo.

* —Found a drum of PH 1 from DRMO stored next to drum of PH 12 from USPCI Grassy Mountain (PH checked by HRI personnel). PH 12 drum was also dented.

Truck unloading area
